Manhole Inspection Summary

Manhole # S27K__030MH

Insp Date: **6/4/08 1:15 PM**

Location Address: **921 Ryan St**

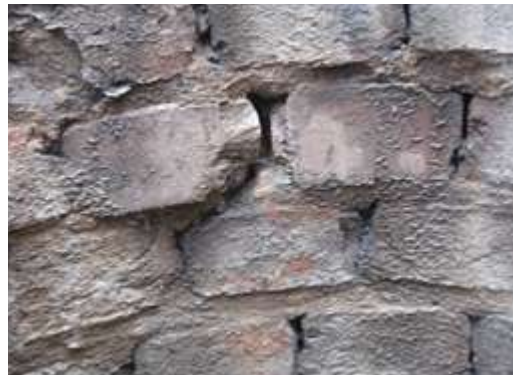
Defect 5

Condition: ☐ Sound ☐ Cracked ☐ Root Intrusion ☐ Loose Brick ☒ **Deteriorated**

Infiltration: ☐ None ☐ Joint ☐ Cracks ☒ **Mortar** ☐ Roots ☐ Wall

corbel missing mortar

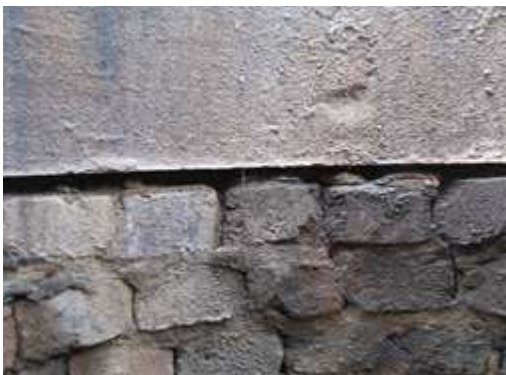
Defect 4

Condition: ☐ Sound ☐ Cracked ☐ Root Intrusion ☐ Loose Brick ☒ **Deteriorated**

Infiltration: ☐ None ☐ Joint ☐ Cracks ☒ **Mortar** ☐ Roots ☐ Wall

frame-chimney connect infiltration missing mortar

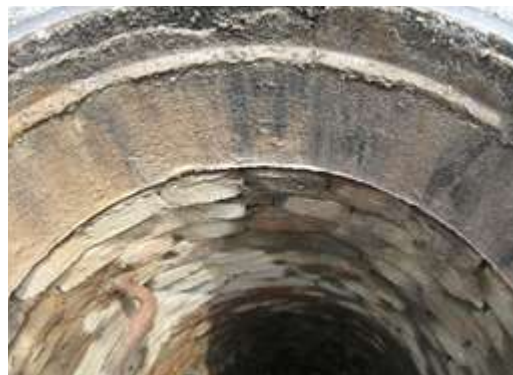
Defect 3

Condition: ☐ Sound ☐ Cracked ☒ **Leaks**

frame-lid infiltration

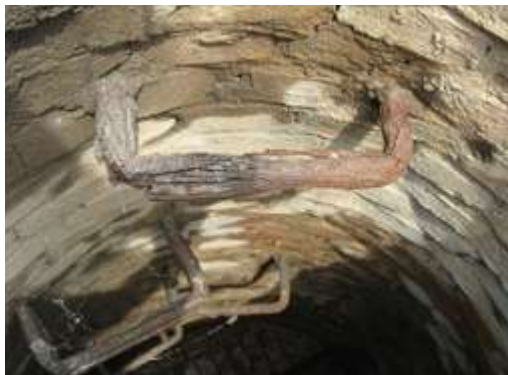
Defect 1

Count: **6** Missing: **0** ☒ **Corroded**

corroded rungs; infiltration from
frame-chimney joint

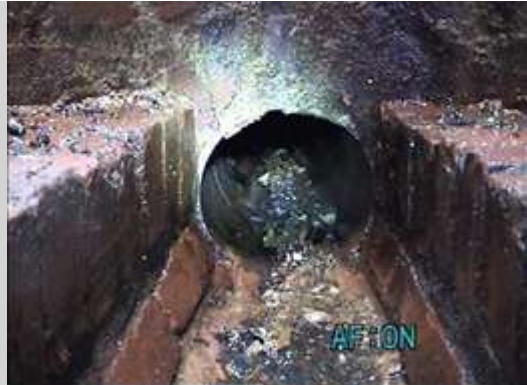
12 O'Clock Outflow

Pipe Height: **8.4** (in.) Rod and Bar (Angled)
Pipe Material: **Clay** ☐ Pipe Lined
Invert Depth: **9.62** (ft.) Flow Characteristics: **None**
Deposits: ☐ None ☐ Mud ☐ Sludge ☒ **Debris** ☐ Grease
Silt Depth: **1** (in.) Deposits Extent: **Light**
Infiltration: **None** Pipe Seal Cond: **Sound**
